Safeguarding hot water supplies

PASSING THE HARDNESS TEST

Preventing limescale deposits

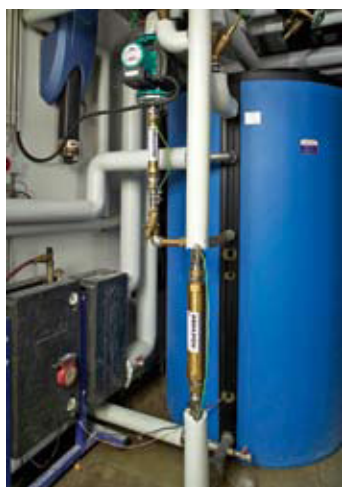
Protected hot water system

WHO estimates that more than 20,000 people die in Europe each year from dangerous Legionella. Utility water temperatures of over 60°C are important to fight these bacteria. Yet the limescale precipitation is then particularly aggressive, which is why two further active anodes "AB H50" and "AB S20" protect the hot water system

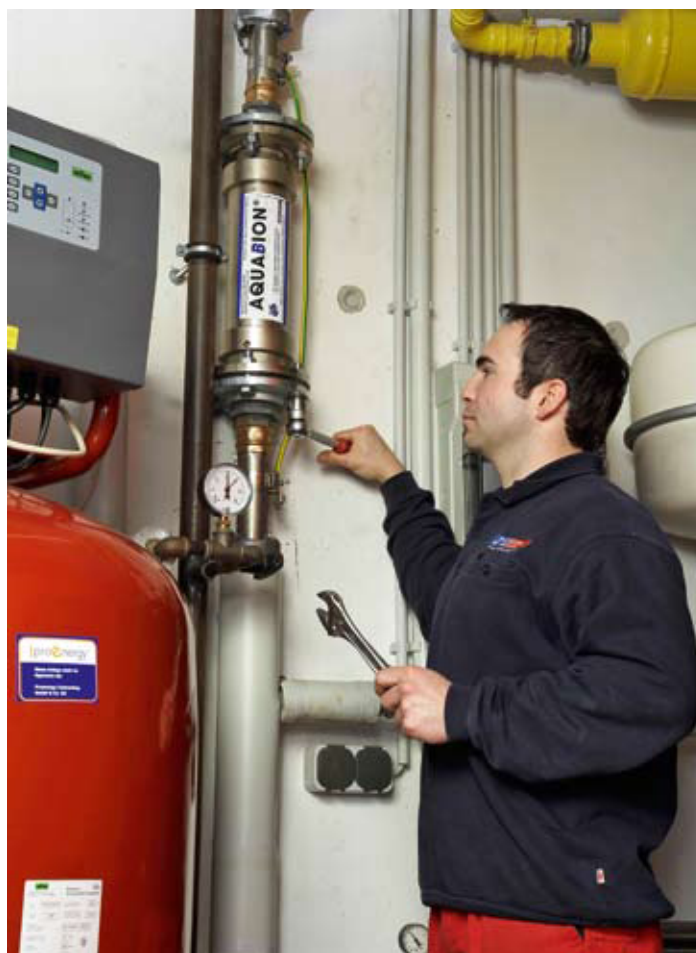
Limescale deposits

"Aquabion" is available to fit every pipe diameter. "Type AB F65" for DN 65 was installed here in the cold water main. Thanks to the artificial precipitation of limescale immediately behind the water pipe, the altered lime crystals now flow off through the pipe network without danger.

In this situation, Proenergy's help desk recommended its partner, ION Deutschland GmbH, Düsseldorf. This firm has a cooperation agreement with Proenergy and supplies its "Aquabion" water treatment system (www.aquabion.de). Where medium-hard to hard water is concerned, as in Langen, the active anode works as a lime converter.

The new, microscopically visible, neutral crystals no longer adhere to surfaces, but rather flow off with the stream of water. Once the "Aquabion" cartridges had been installed, no more complaints were received whatsoever up to the first maintenance date six months later.
